Service Manual

8065752478 Rev. B, CATALOG NO.
906-2150-001 Rev. B, TEXT ONLY

***Centurion** Vision System Service Manual**
8065752478

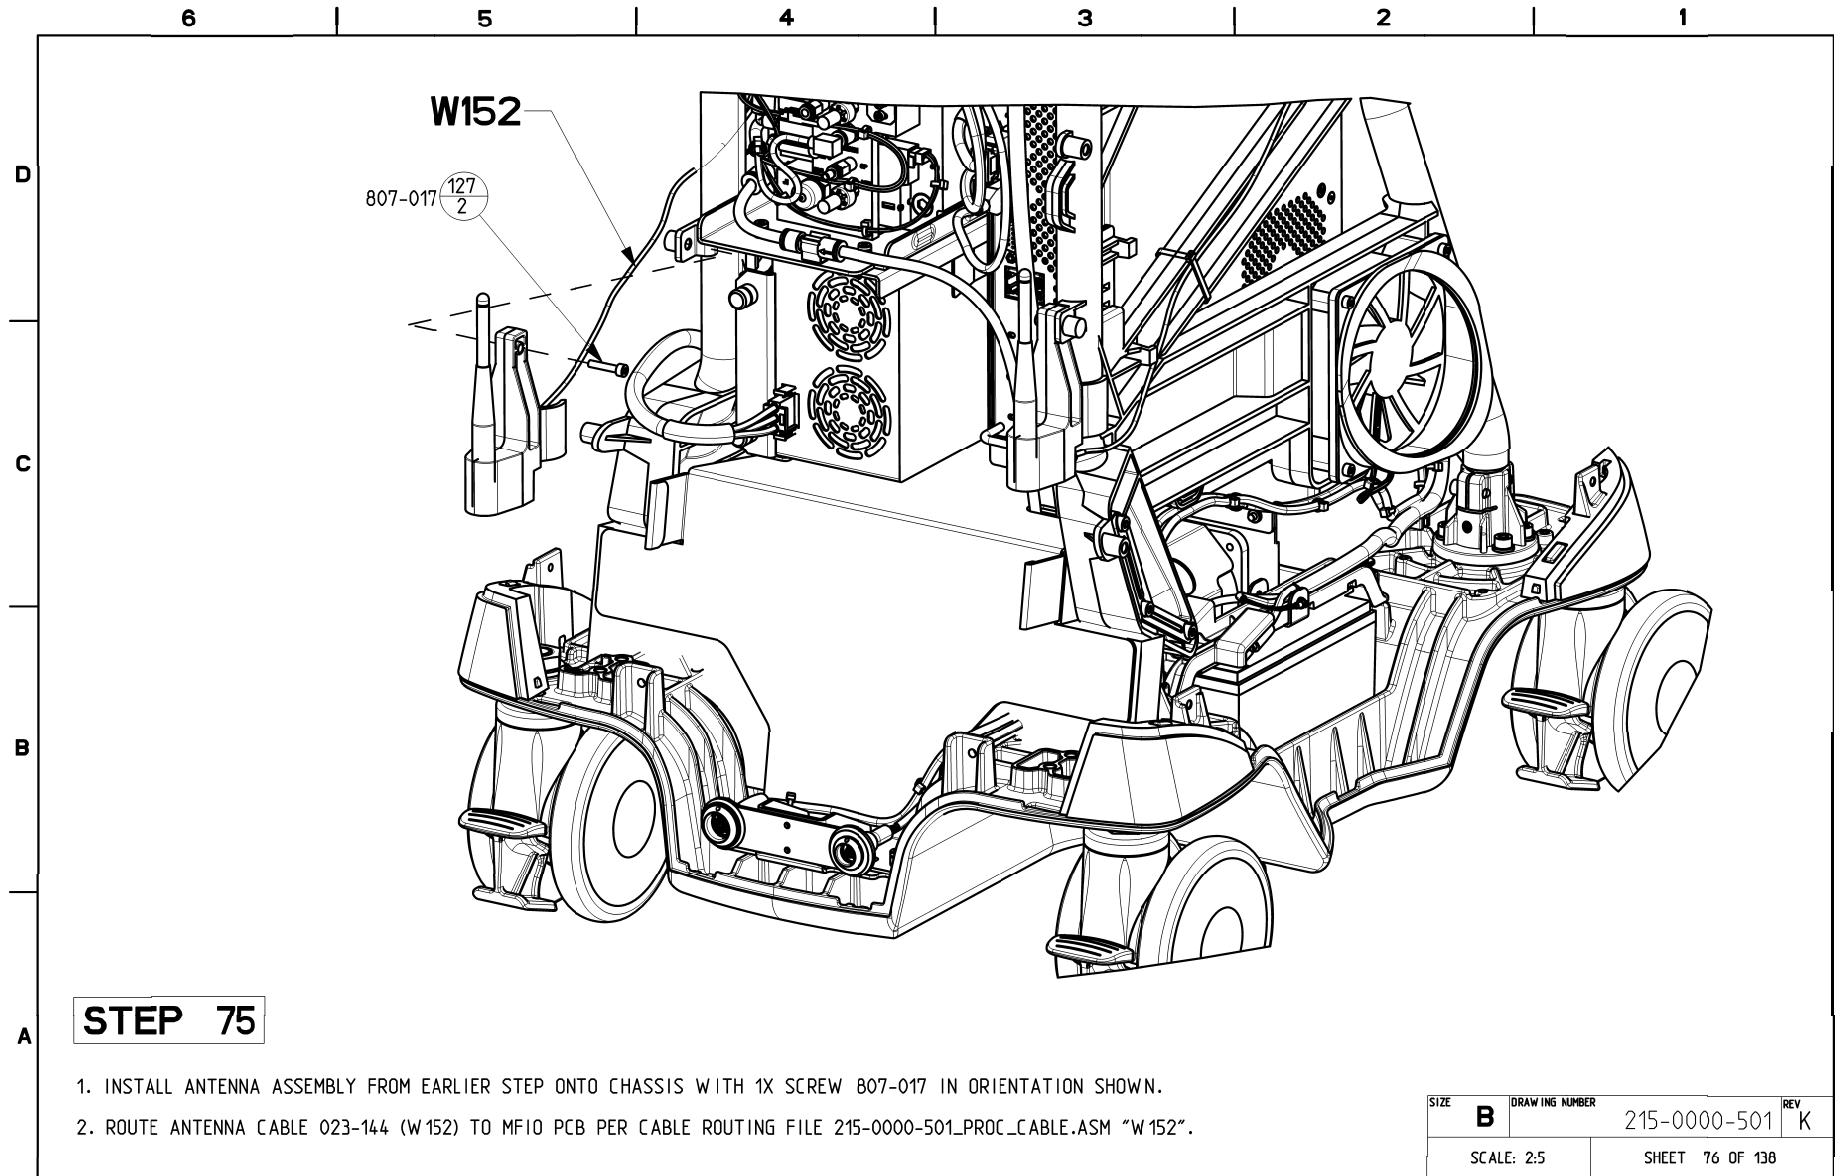
SIZE	DRAWING NUMBER	REV
B	215-0000-501	K
SCALE: 2.5		SHEET 76 OF 138

STEP 75

1. INSTALL ANTENNA ASSEMBLY FROM EARLIER STEP ONTO CHASSIS WITH 1X SCREW 807-017 IN ORIENTATION SHOWN.
2. ROUTE ANTENNA CABLE 023-144 (W152) TO MFIO PCB PER CABLE ROUTING FILE 215-0000-501_PROC_CABLE.ASM "W152".

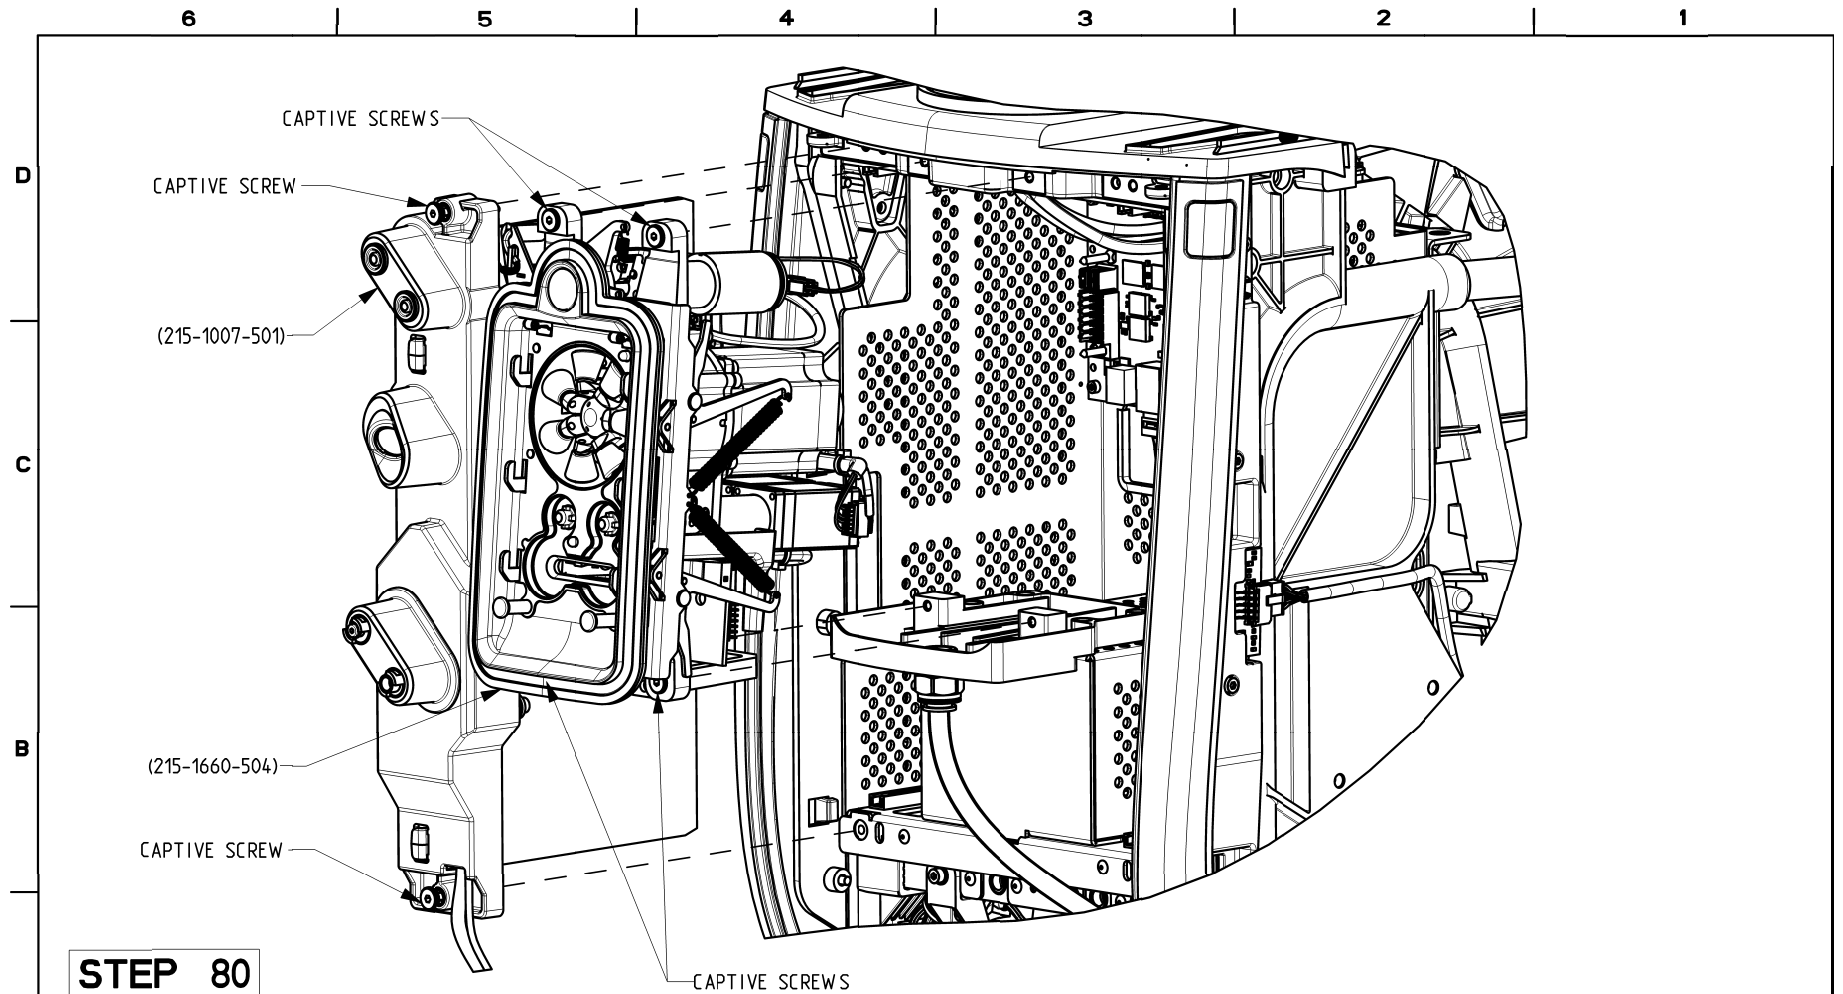
SIZE	B	DRAWING NUMBER	215-0000-501	REV	K
SCALE: 1:2		SHEET 81 OF 138

STEP 80

1. INSTALL FLUIDICS MODULE 215-1660-504 AND FLUIDICS PCB ASSY 215-1007-501 FROM PREVIOUS STEP INTO CONSOLE TOGETHER AS SHOWN.
2. SECURE FLUIDICS MODULE 215-1660-504 TO CHASSIS WITH 4X CAPTIVE SCREWS SHOWN ABOVE.
3. SECURE FLUIDICS PCB ASSY 215-1007-501 TO CHASSIS WITH 2X CAPTIVE SCREWS SHOWN ABOVE.
4. INSERT FLUIDICS MODULE 215-1660-504 DHR DATA SHEET INTO OVERALL CONSOLE DHR PACKET.

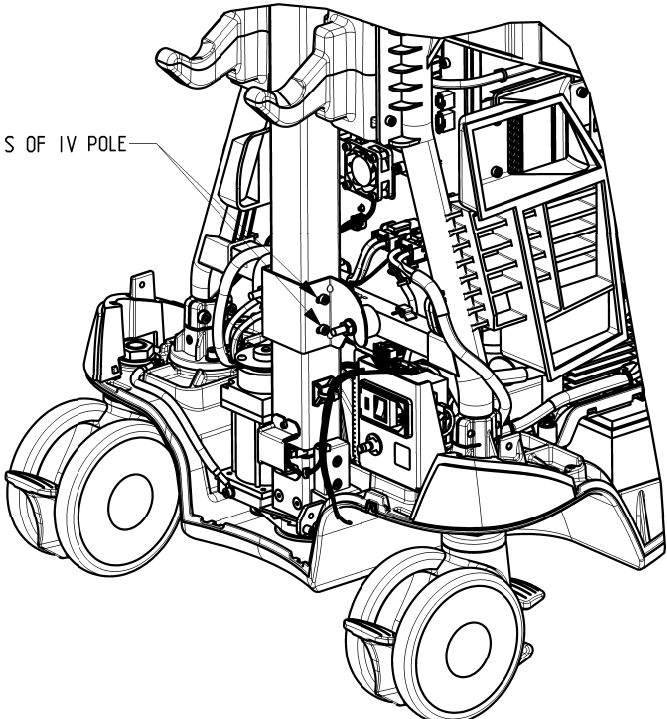
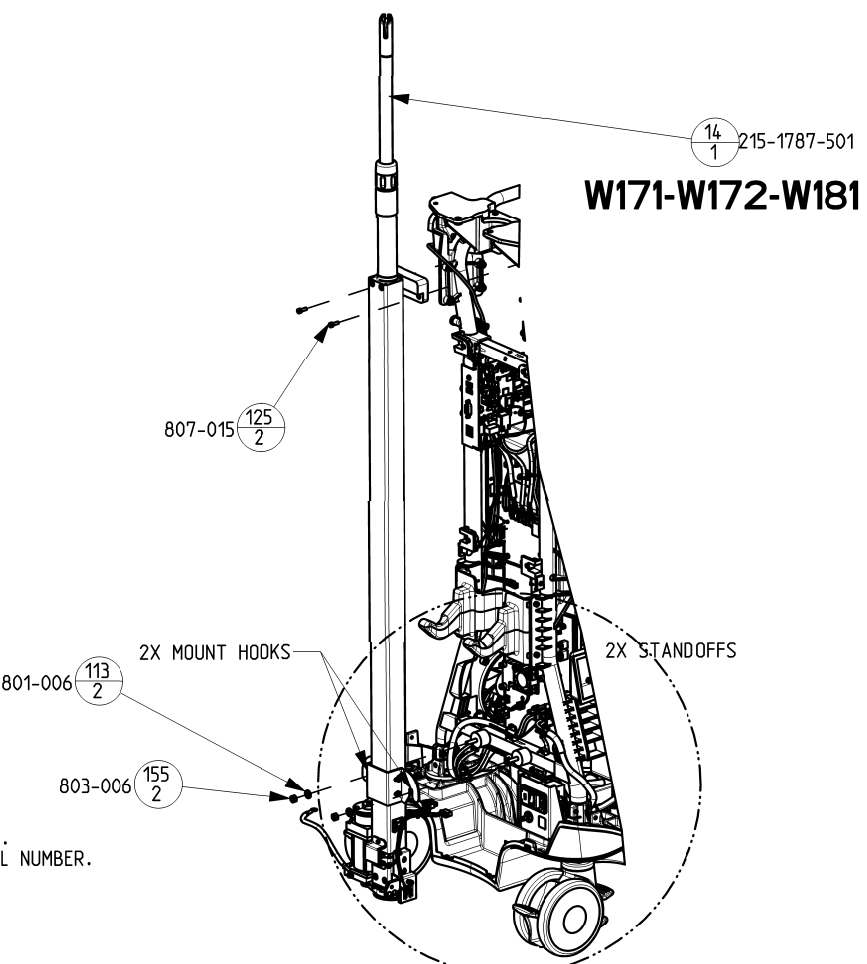
SIZE	B	DRAWING NUMBER	215-0000-501	REV	K
SCALE: 3:20		SHEET 92 OF 138

DETAIL A

W171-W172-W181

STEP 91

1. CONFIRM SERIAL NUMBER OF IV POLE 215-1787-501 MATCHES SERIAL NUMBER OF CONSOLE. STAMP DHR DATA SHEET TO CONFIRM IV POLE SERIAL NUMBER MATCHES CONSOLE SERIAL NUMBER.
2. INSERT IV POLE DHR DATA SHEET INTO OVERALL CONSOLE DHR PACKET.
3. INSTALL IV POLE ASSY 215-1787-501 ONTO CHASSIS WITH 2X SCREWS 807-015.
4. INSTALL 2X WASHERS 801-006 AND 2X NUTS 803-006 ONTO IDENTIFIED STANDOFFS OF CHASSIS ABOVE.
5. FULLY TIGHTEN 2X IDENTIFIED SCREWS OF IV POLE 215-1787-501 SHOWN IN DETAIL A.
6. ROUTE 2X IV POLE CABLES (W171 & W172) TO MFIO PCB PER CABLE ROUTING FILE 215-0000-501_PROC_CABLE.ASM "W171-W172-W181."

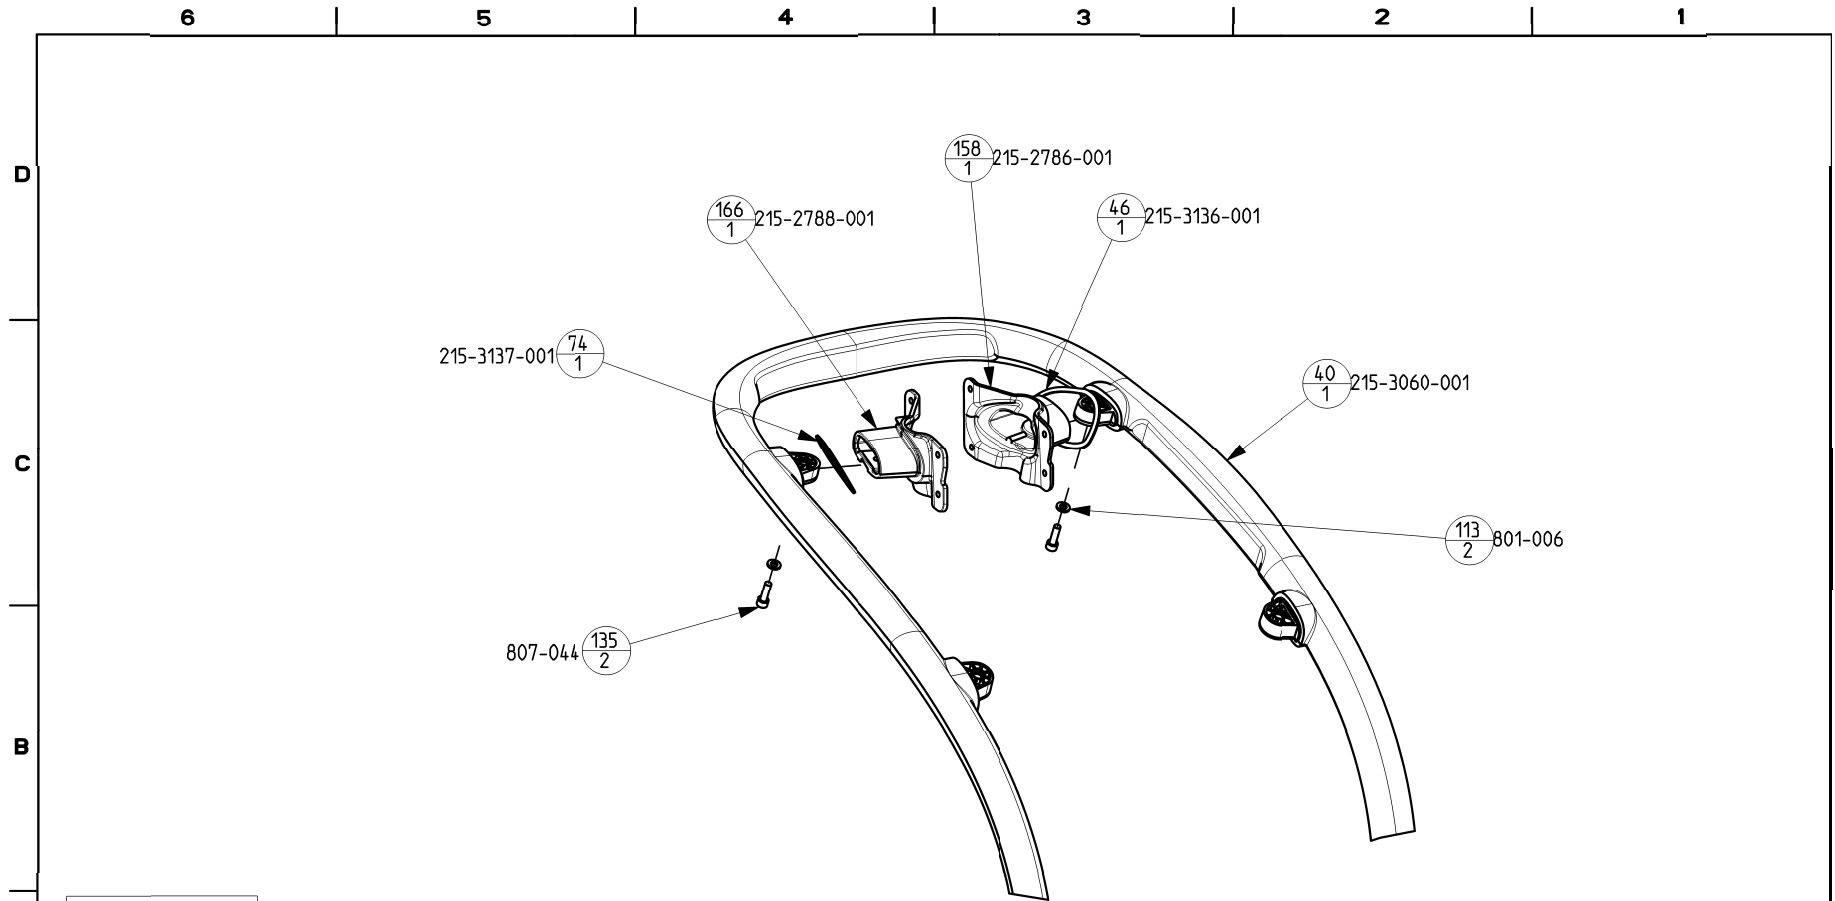
STEP 100

1. REMOVE ADHESIVE BACKING FROM GASKETS 215-3137-001 AND ADHERE ONTO WRAP HANDLE MOUNT 215-2788-001 AS SHOWN.
2. REMOVE ADHESIVE BACKING FROM GASKETS 215-3136-001 AND ADHERE ONTO WRAP HANDLE MOUNT 215-2786-001 AS SHOWN.
3. INSTALL WRAP HANDLE MOUNT 215-2786-001 AND 215-2788-001 ONTO WRAP HANDLE 215-3060-001 IN ORIENTATION SHOWN.
SECURE WITH 2X WASHERS 801-006 AND 2X SCREWS 807-044. INSTALL ALL SCREWS AND WASHERS ONTO HANDLE BUT DO NOT TIGHTEN IN THIS STEP, WILL BE TIGHTENED LATER.

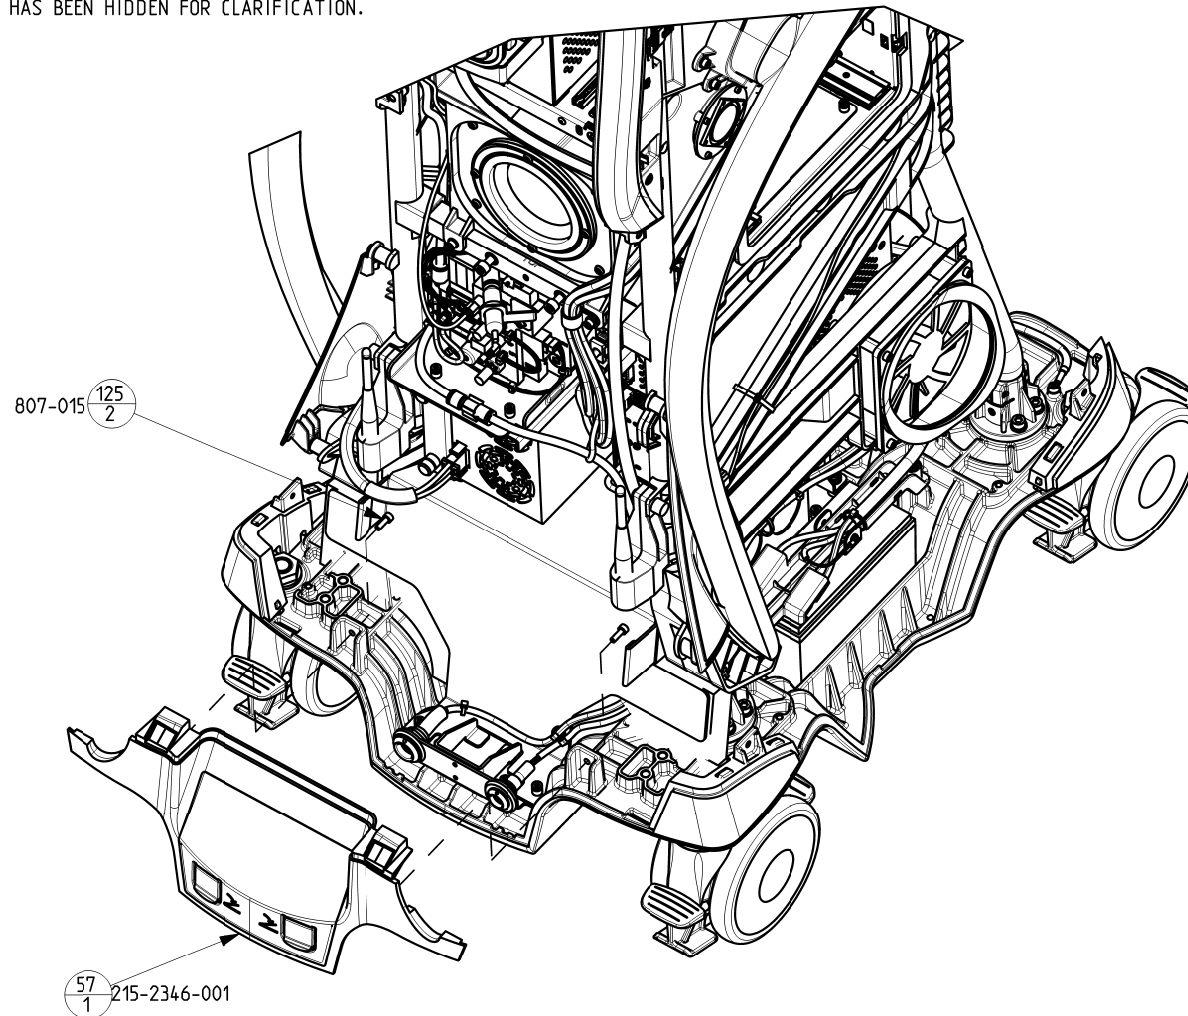
STEP 111

1. INSTALL FRONT FOOT HANDLE PANEL 215-2346-001 ONTO BASE 215-1219-001 AND SECURE WITH 2X SCREWS 807-015.

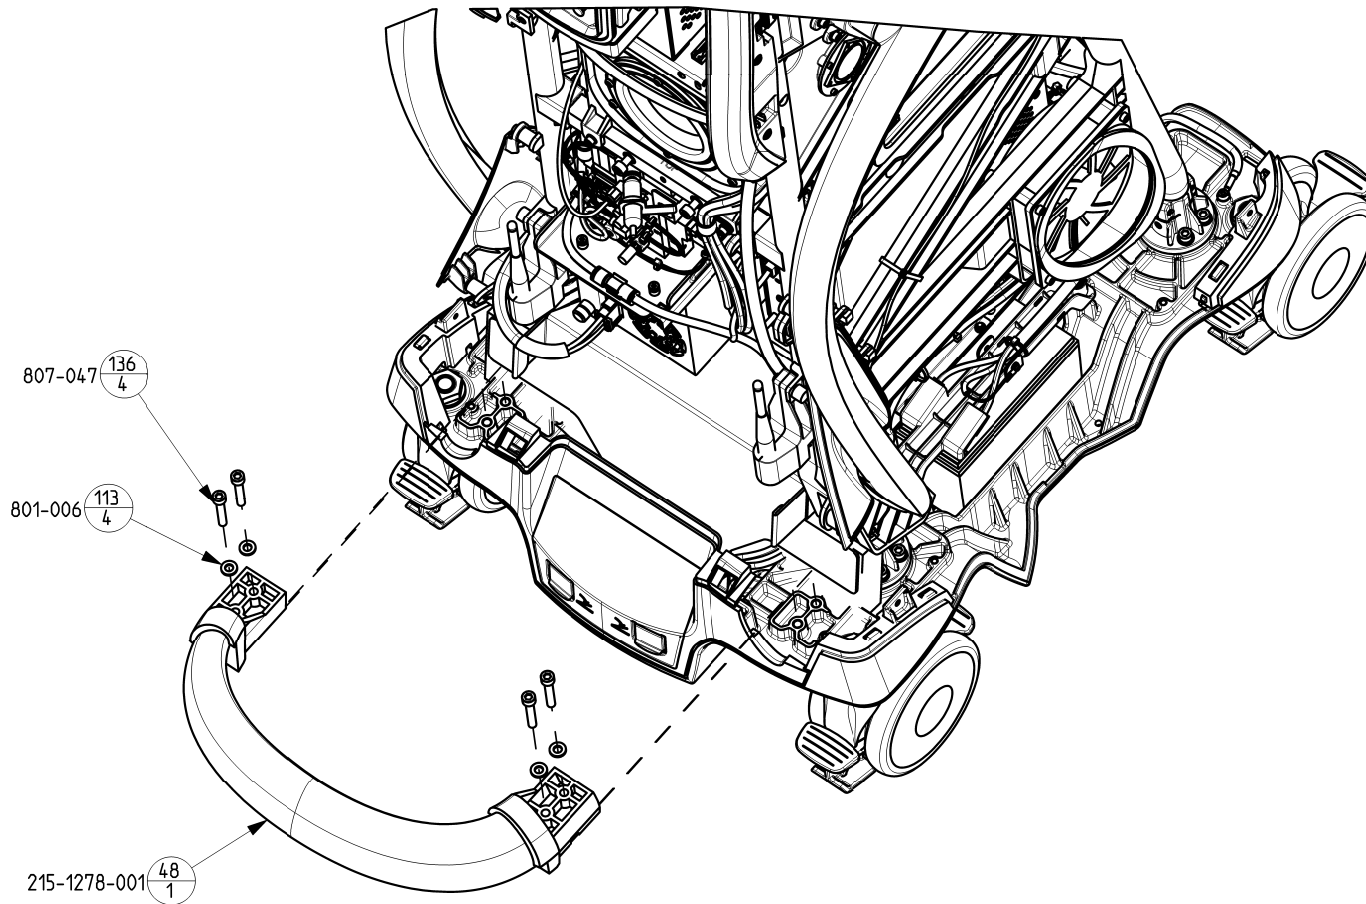
STEP 112

1. INSTALL FRONT BUMPER 215-1278-001 ONTO BASE 215-1219-001 WITH 4X WASHERS 801-006 AND 4X SCREWS 807-047.

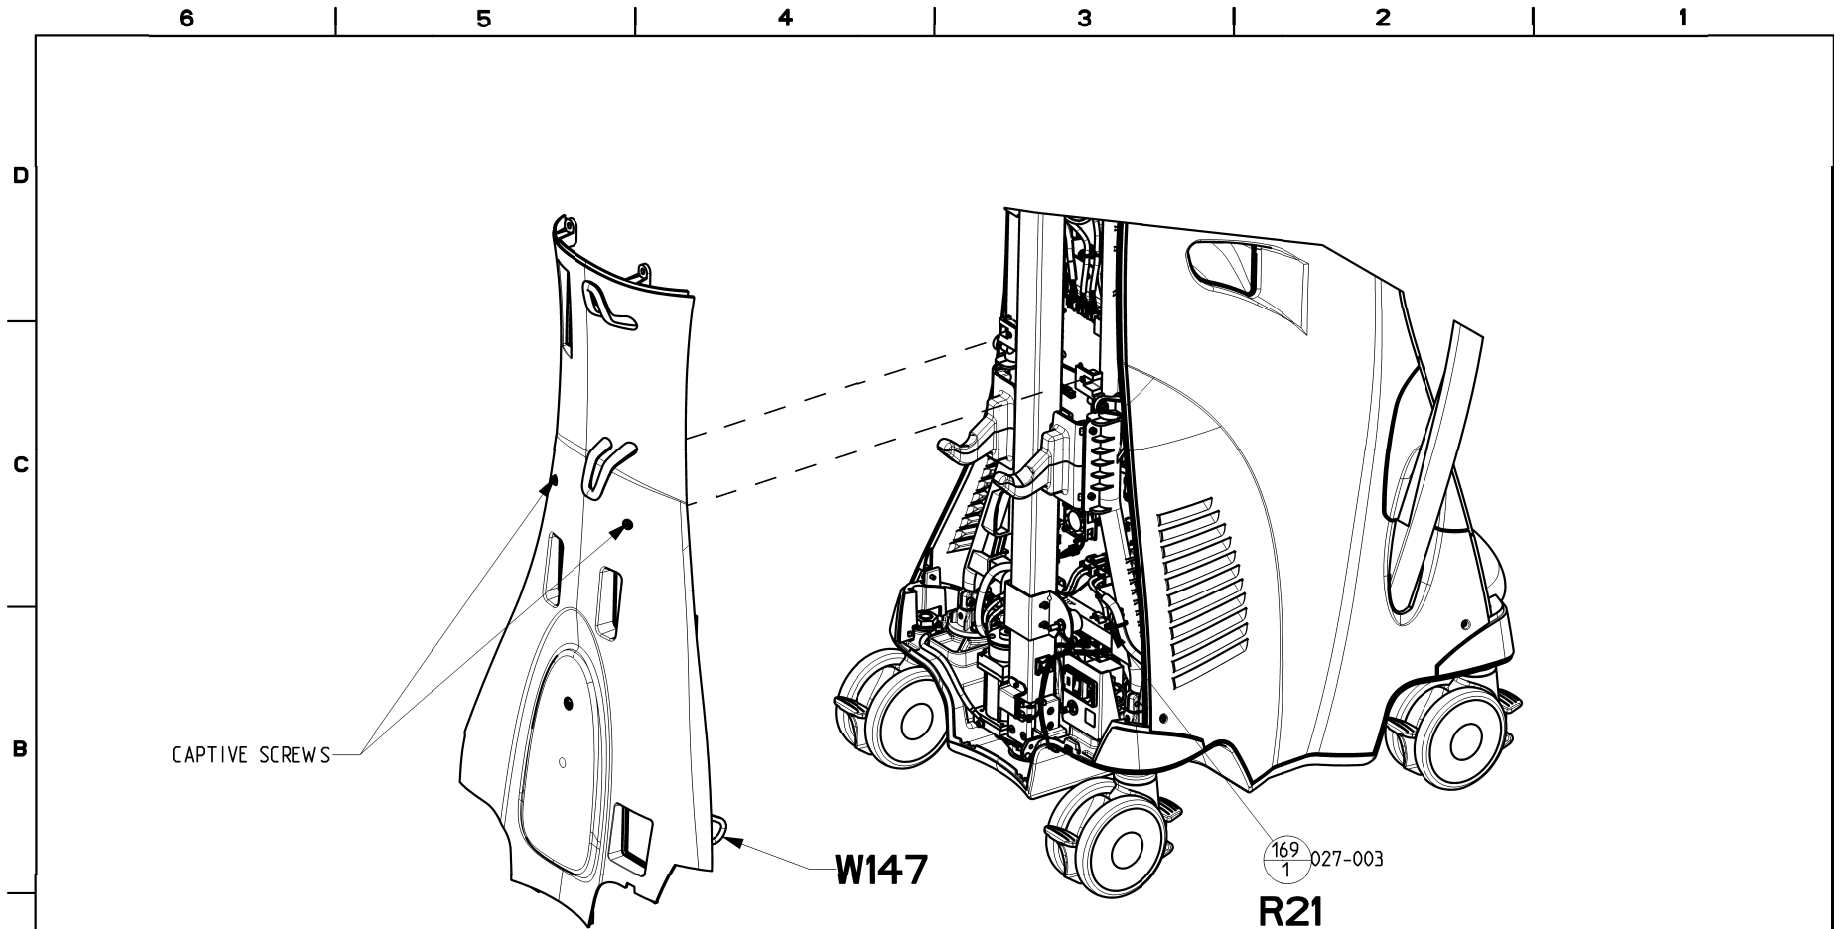
STEP 125

1. CONNECT FTSW CHARGER CABLE 215-2778-001 TO MFIO PCB PER CABLE ROUTING FILE 215-0000-501_PROC_CABLE.ASM "W147".
2. SECURE FTSW CHARGER CABLE 215-2778-001 (W147) AND BATTERY CABLE 215-1130-001 (W130) TO CHASSIS WITH TIE WRAP 027-003 IN IDENTIFIED LOCATION. REFERENCE CABLE ROUTING FILE 215-0000-501_PROC_CABLE.ASM "R21" FOR DETAILS.
3. INSTALL LOWER REAR PANEL ASSY 215-2822-501 ONTO CONSOLE AND SECURE WITH 2X CAPTIVE SCREWS.

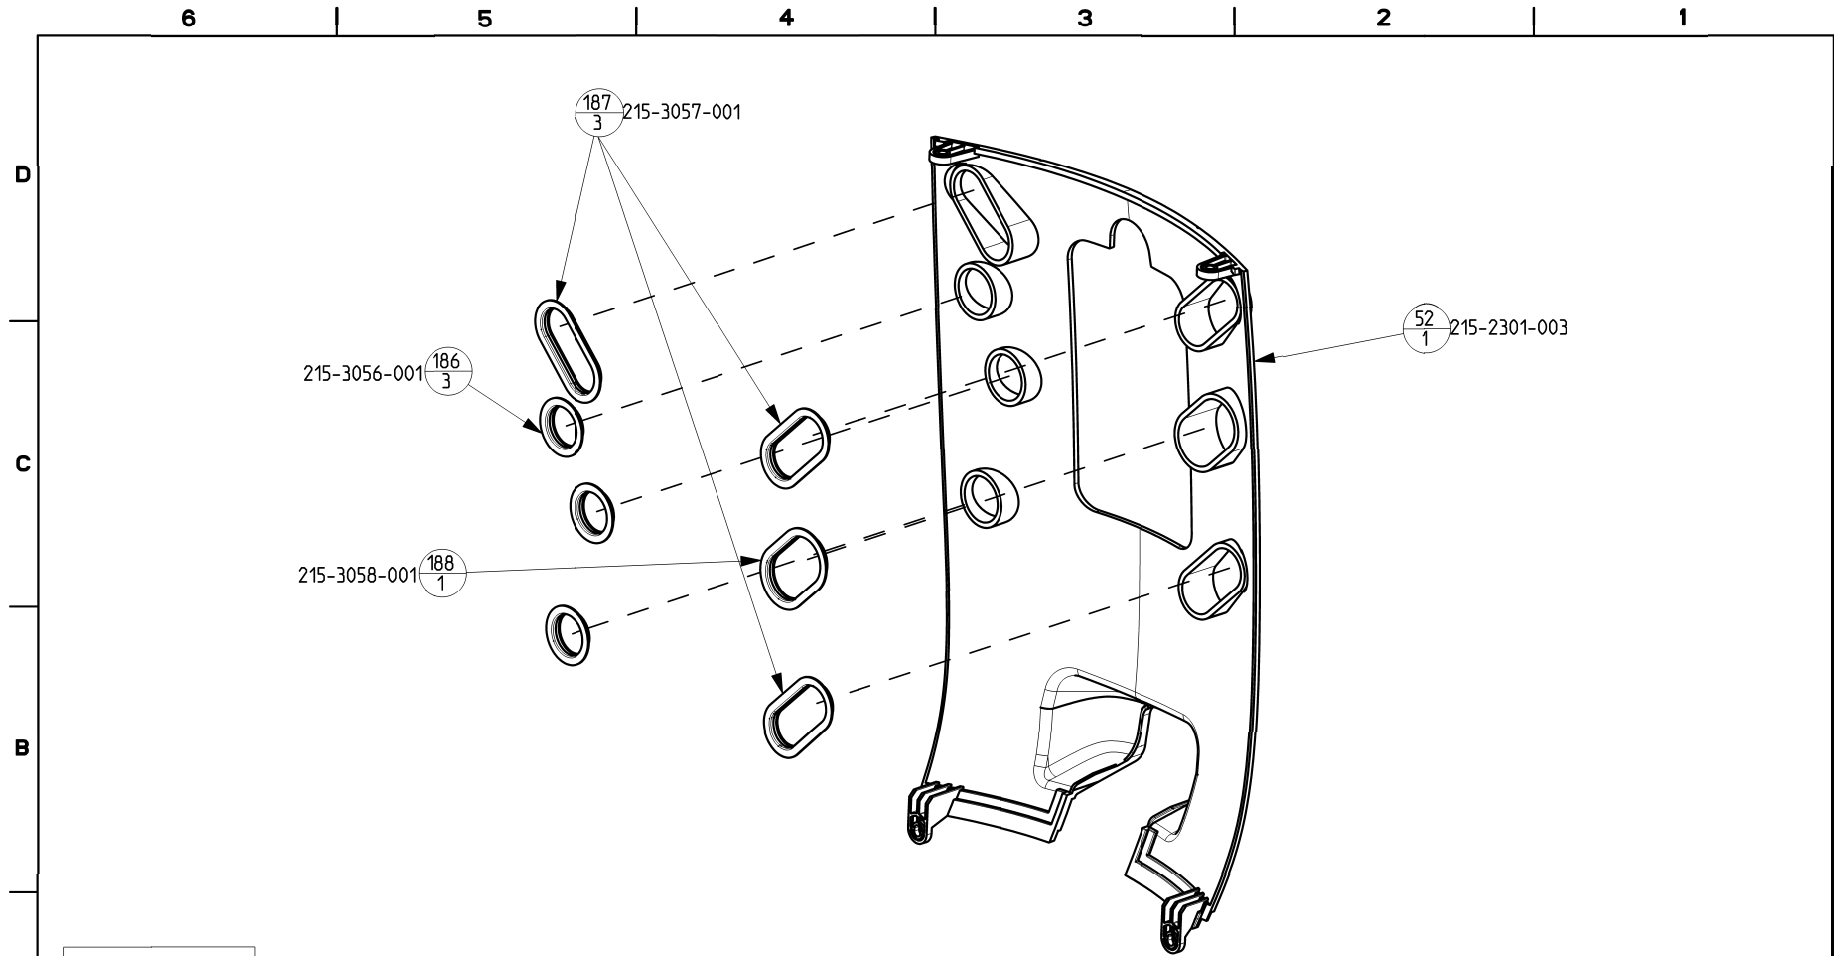
STEP 128

- A** 1. INSTALL 3X GASKETS 215-3056-001, 3X GASKETS 215-3057-001, AND GASKETS 215-3058-001 ONTO FRONT PANEL 215-2301-003 IN LOCATIONS SHOWN ABOVE.
